Assessment of Rainwater Harvesting In Northern Ghana

Master of Engineering in Civil and Environmental Engineering
at the
MASSACHUSETTS INSTITUTE OF TECHNOLOGY

June 2009

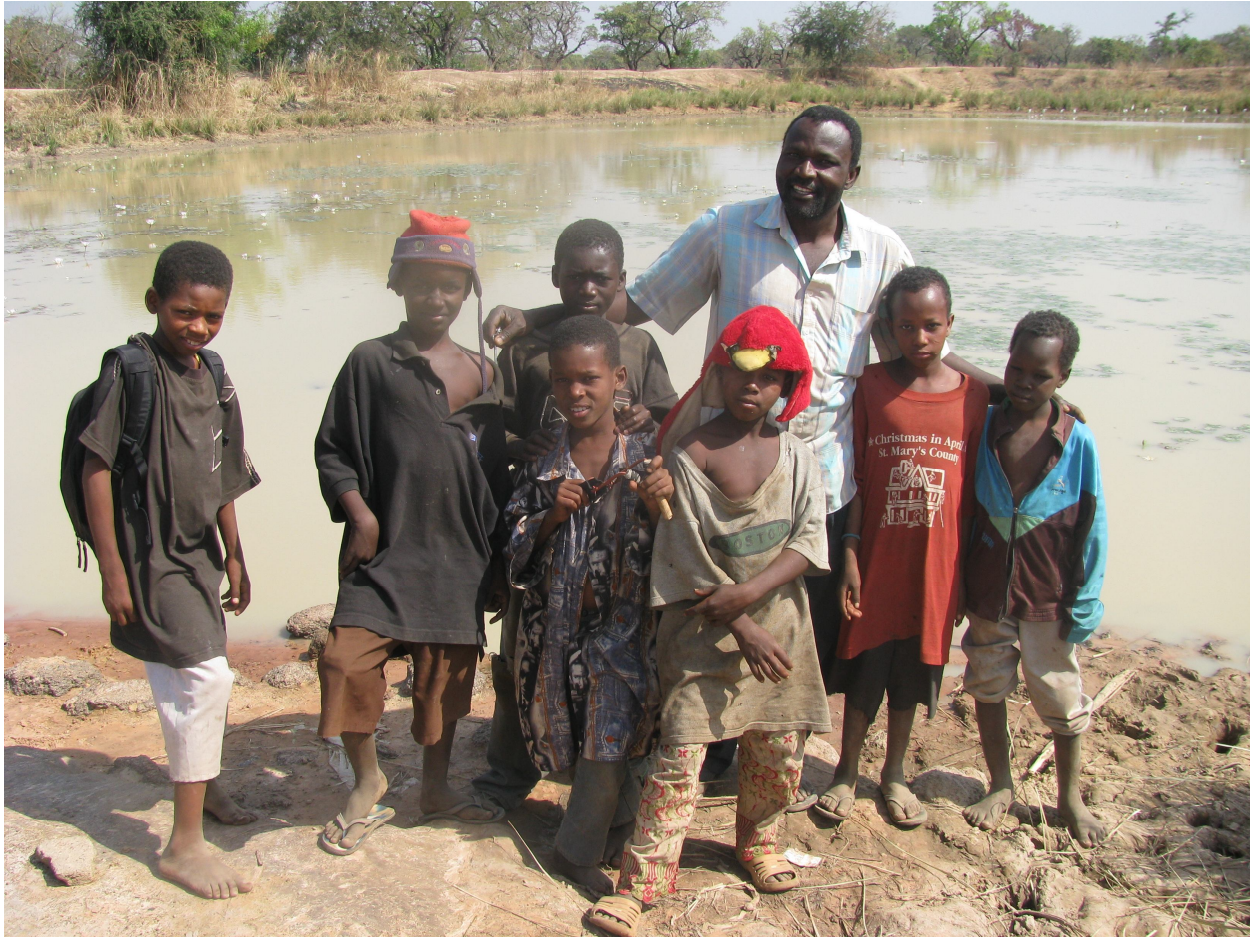
Figure 3: Unprotected dugout: Pong-Tamale, Northern Region, Ghana (Photo Courtesy of Shanti Klieman) This is an alternate source for the Boys Correctional School when rainwater or other improved supplies are unavailable

Waterborne diseases are spread through contaminated drinking water supplies. In the Northern Region, 56% of people use unimproved water sources (unprotected well/spring, river/canal) for drinking water supply, (VanCalcar, 2006) an example of which is shown in Figure 3.

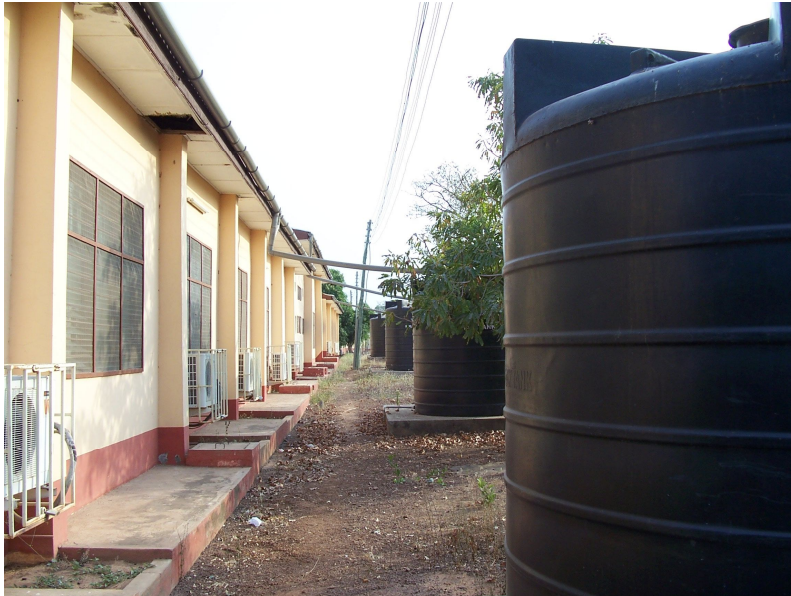
Name: World Vision Ghana Rural Water Supply Office, Savelugu, Ghana
Location:
Number of Users: Employees at office (≈ 40)
Tank Type: $5 \times 10,000$ L Polytanks
Guttered Roof Area: 1129m^3
Cost: \$8,333
Maintenance Issues: PVC gutters have failed
Water Quality Results: n/a

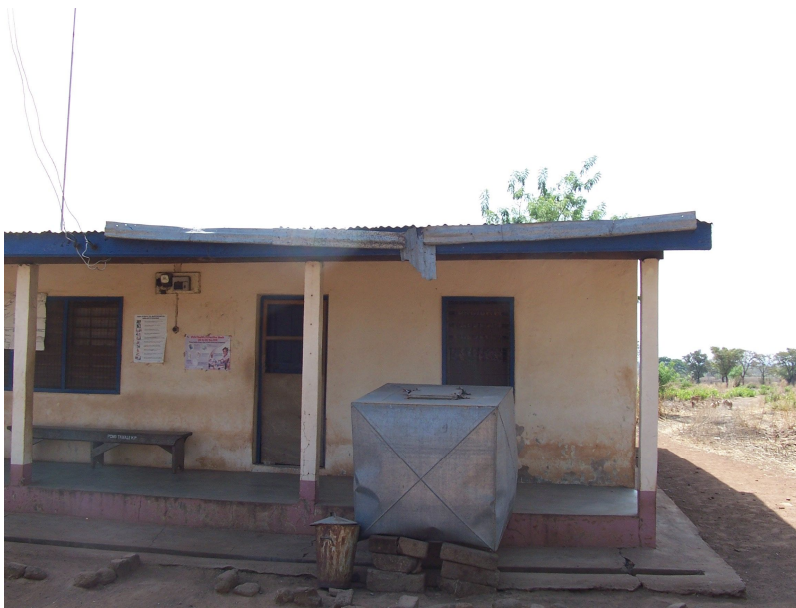
Name: Pong Tamale Health Clinic

Maintenance Issues: Storage tank poorly mounted on blocks, tank leaks.

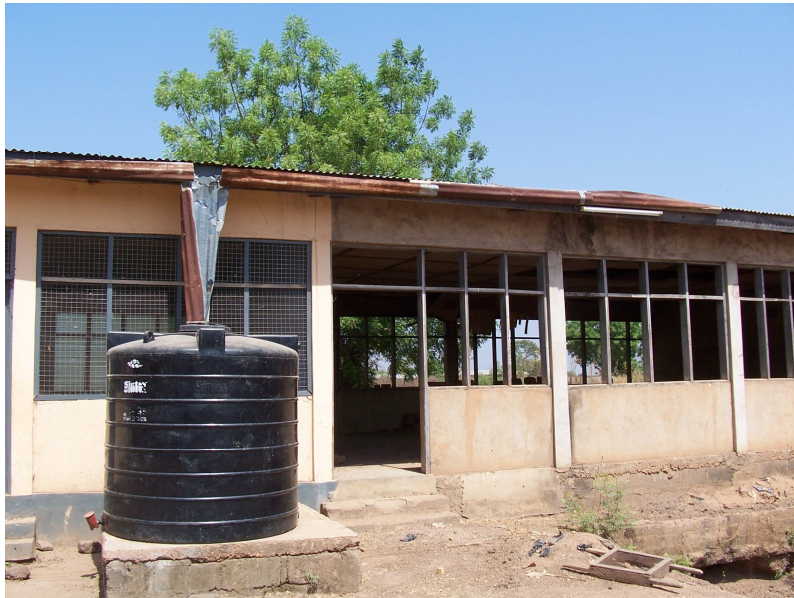
Name: Pong Tamale Vocational School Boys Correctional Center
Pong-Tamale, Ghana
Number of Users: 200 people
Tank Type: 2 Sintex brand SCT-35 1000L plastic water tanks
Guttered Roof Area: 57m² and 69m²
Total Roof Area: 537m²
Cost: Unknown, financed by International Labor Organization
Maintenance Issues: None.
Water Quality Results: RWH tank #2 positive for total coliform: 99 CFU/100ml (sample fetched using local fetching cup)

Figure 10: Pong-Tamale Vocational School Boys Correctional Center Rainwater Harvesting Tank #1

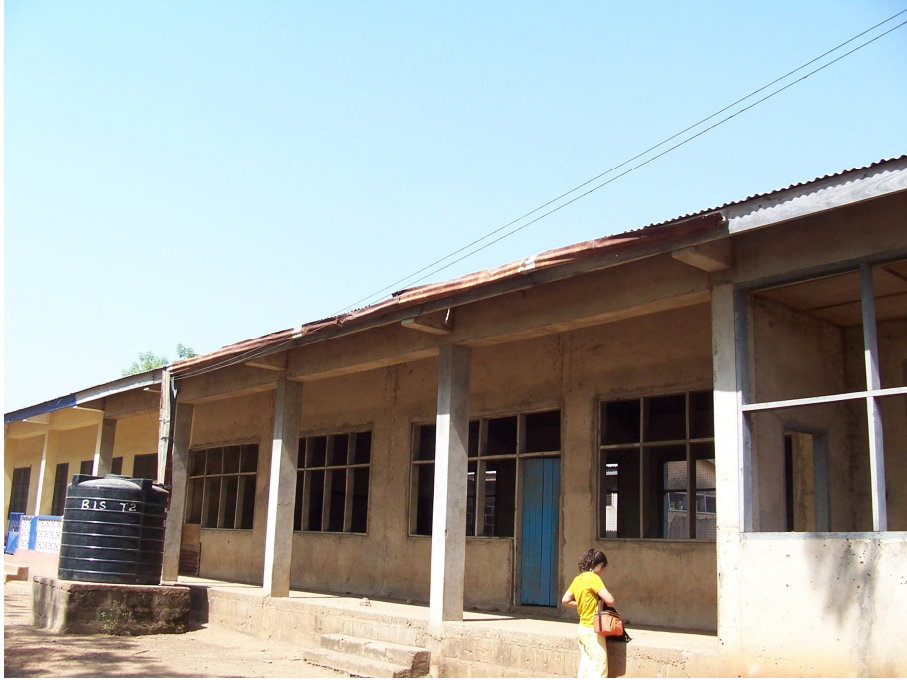
Figure 11: Tank #2 Pong Tamale Vocational School Boy's Correctional Center

The current system is cleaned four times a year by students of the school. The tanks are cleaned with soap and hand scrubbing. The two tanks only provide enough water for two days of drinking and cooking water use for the staff, children and people who come from the surrounding community to fetch before the water runs out and hence is only reliably providing water during the rainy season.

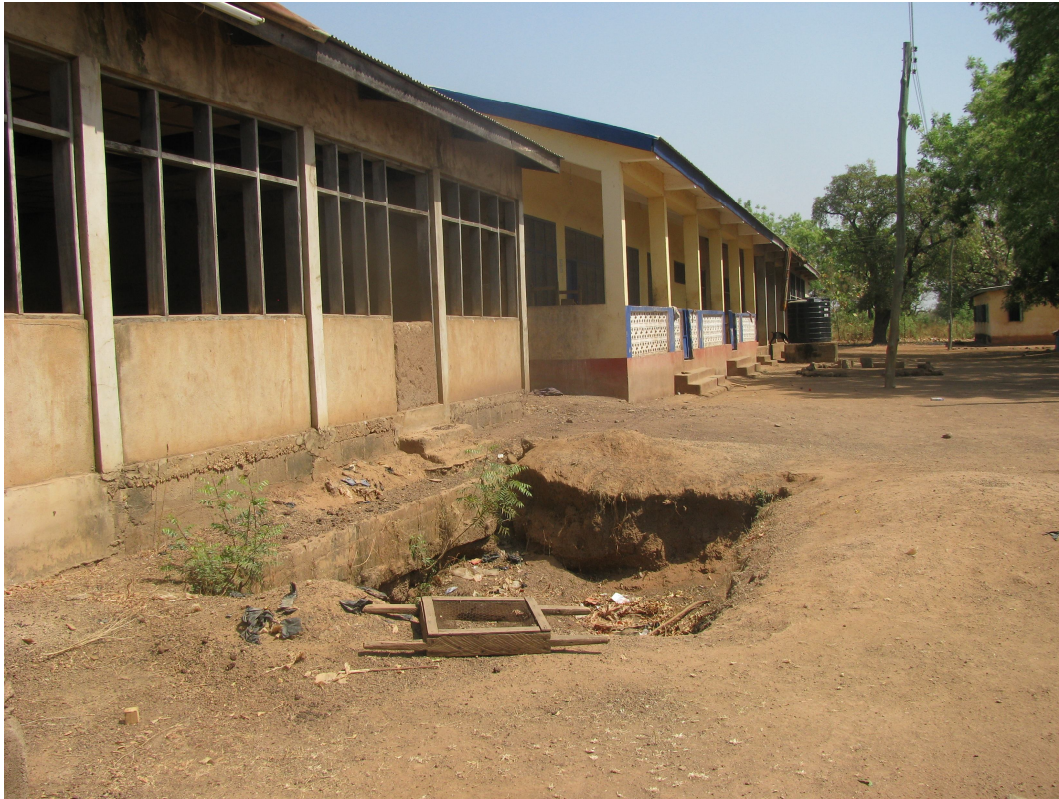
Figure 12: Pong Tamale Vocational School proposed site of underground storage tank

The school has two rainwater harvesting systems of similar design in the front of the school. There is also a constructed pit on site, which Mr. Haruna hopes to convert into an underground concrete water storage tank in the future. (Figure 12) The plastic Sintex brand water tanks were provided by the International Labor Organization. The guttering is constructed of zinc roof sheet as at the Pong Tamale Health Clinic. Only a small fraction of the very large roof is used for harvesting. Francis reported that the tanks were more than filled using only a fraction of the roof area and discussed the need for more storage in the system. He envisioned offering a course that taught students reinforced concrete construction. This would allow materials for an underground storage tank to be purchased as part of the course. Labor would also be free as it would be provided by his students.

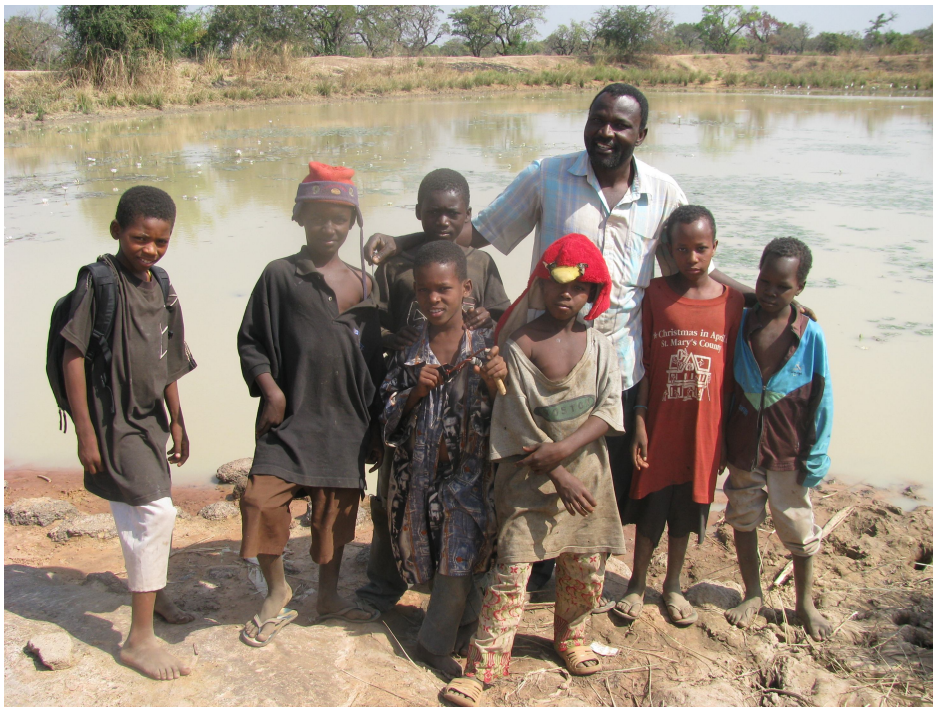
Figure 14: Headmaster Francis Haruna and students in front of Pong-Tamale dugout

The alternative sources for this community include water purchased from the Veterinary Laboratory Treatment Plant, described later in this chapter, and the Pong-Tamale dugout, pictured in Figure 14. The turbidity of the dugout was measured at 554 NTU. The bacteriological quality of this water was 8,900 total coliform CFU/100ml and 1,900 *E.coli* CFU/100ml.

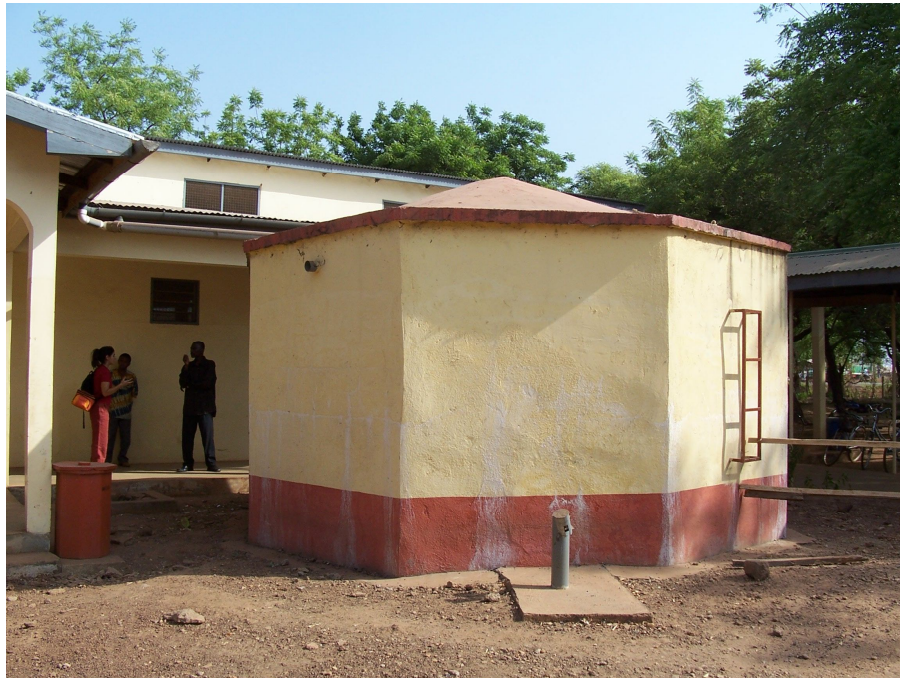
Name: Savelugu Hospital
Savelugu, Ghana
Number of Users: hospital
use and 50-100 fetching
Tank Type: 1 World
Vision 75m³ octagonal
cement block storage tank
Guttered Roof Area: 76m²
Total Roof Area: 189m²
Cost: \$3500 subsidized
by World Vision
Maintenance Issues:
Gutter failure, remains
unresolved
Water Quality Results:
n/a

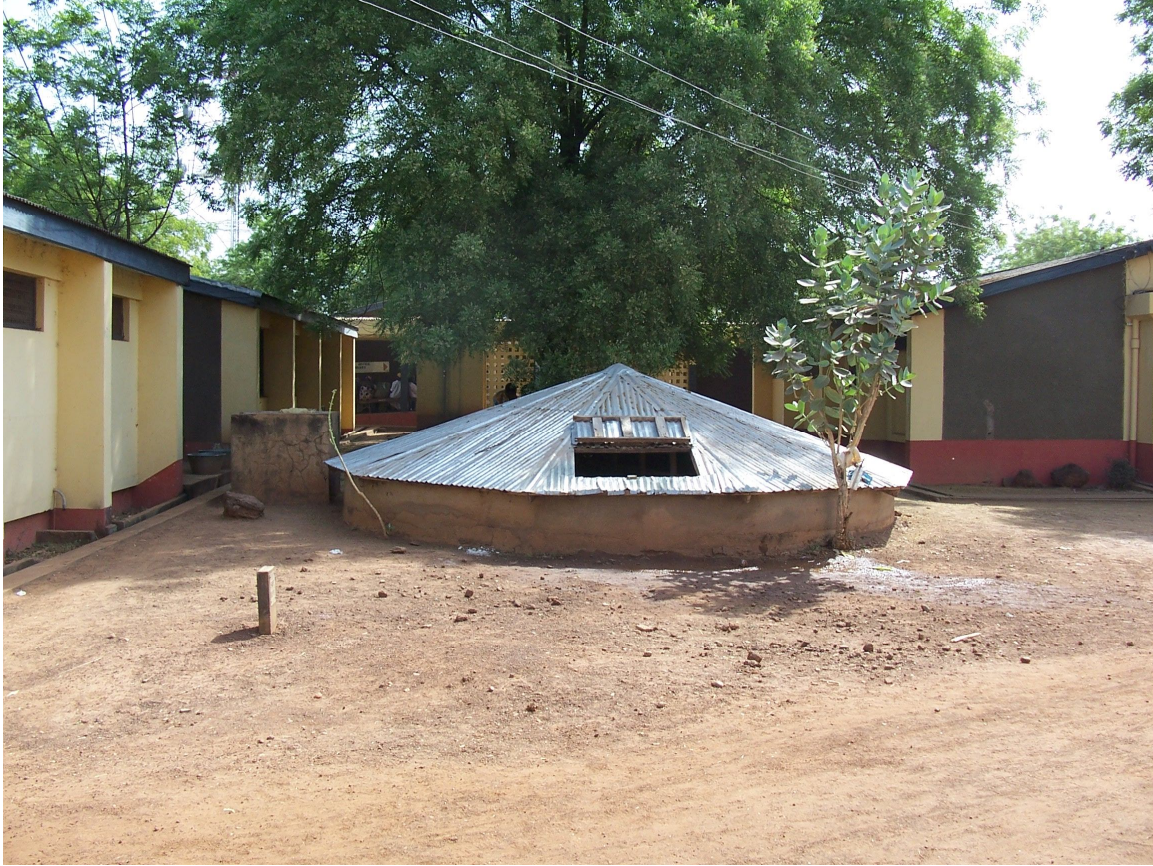
Figure 17: Old Rainwater Harvesting Cistern, Savelugu Hopital (c. 1950's)

Also, at Savelugu Hospital, a rainwater harvesting system had been constructed reportedly in the 1950’s at the time of the hospital construction. It is currently being used as an underground storage tank for piped water, and no guttering was present. (Figure 17) It is accessed via a door in the conical roof. The tank is a reinforced concrete half dome. The system has a sand inlet pre-filter, which is no longer used, as a municipal water line is connected directly to the tank. The water quality in this tank was compromised due to the access door which was left open for people to fetch. The water quality at this location was 2,000 total coliform CFU/100ml and 99 *E.coli* CFU/100ml. This sample had to be fetched so secondary contamination could also be a contributing factor.

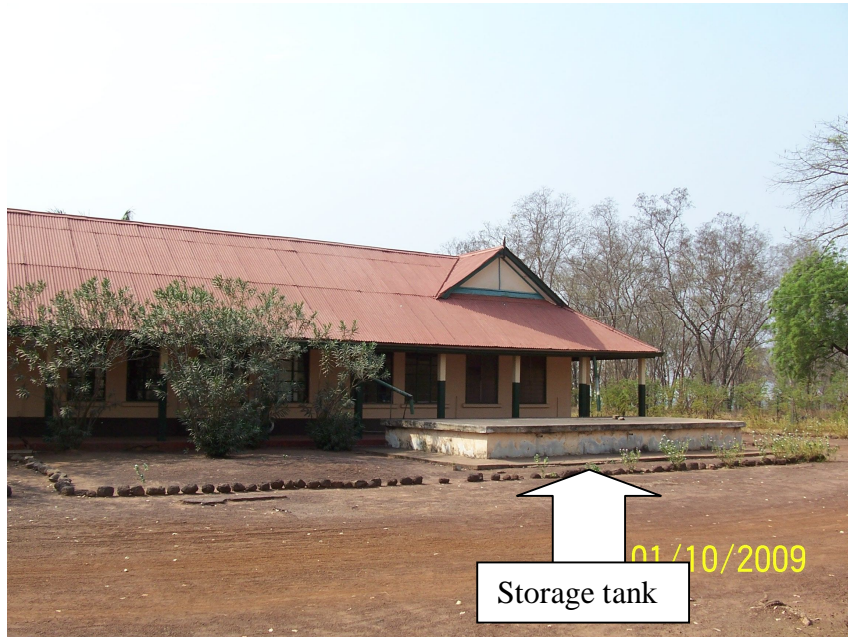
Name: Veterinary College
Pong-Tamale, Ghana
Number of Users: 2000
people in emergency
Tank Type: underground
rectangular reinforced
concrete
Guttered Roof Area: 460m²
Cost: Unknown, constructed
1920's
Maintenance Issues: Gutter
failure, three of five tanks still
functional
Water Quality Results: 99-
200 total coliform
CFU/100ml, 0 *E.coli*
CFU/100ml

Figure 18: Veterinary Laboratory Tank #2

The author visited the Veterinary College in hopes of surveying the water treatment facility supplying water to Pong-Tamale Vocational School. The Veterinary Laboratory was also the site of an extensive rainwater harvesting system reportedly constructed in the 1920's. The entirety of the main complex was guttered and storage was held in three underground storage tanks. One is shown in Figure 18. Water quality in these tanks was relatively unprotected. Fine wire mesh had degraded and did not cover the fetching hole/inlet. The large wire mesh was large enough to allow debris to enter. Sunlight also entered all tanks at the inlet grates. Tank #3's guttering system had failed and had been left non-operational for the last 2 years. The director of the hospital, Ibrahim Seidu, mentioned that he was responsible for making decisions regarding the maintenance of the building and RWH system. He stated that because the RWH system was used only in instances when the Veterinary College Treatment facility was offline, that its maintenance was not a top financial priority. Remarkably, three of five tanks constructed in this manner had survived over eighty years and still hold water. The roofs had collapsed on two others. (Figure 22)

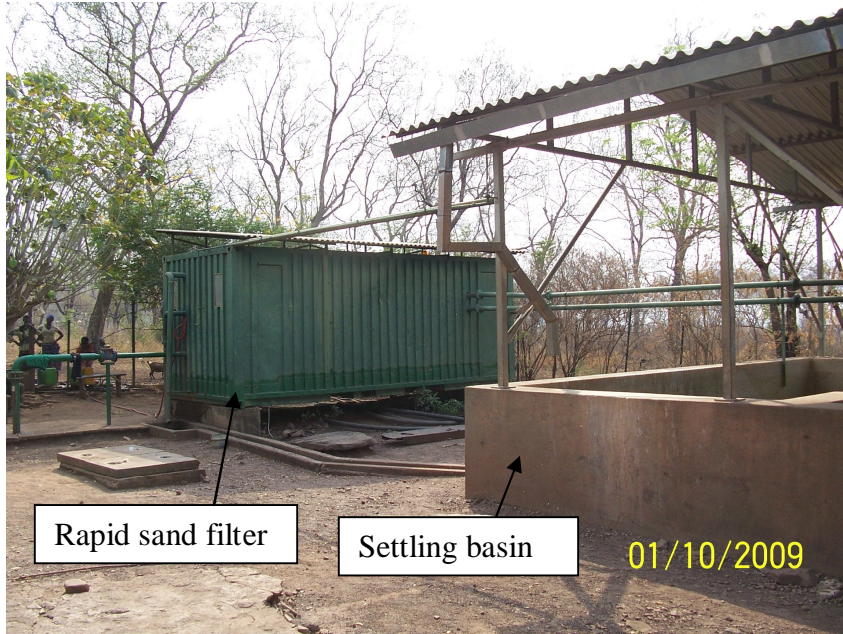
Figure 19: Treatment Facility at Veterinary College: Settling Basin (right) and rapid sand filter (trailer at left, see below)

The treatment facility at Veterinary College provides water to the College and sells water to the surrounding community. People can fetch water at a price of \$0.17 per 40 liters. The treatment is composed of three settling basins and rapid sand filtration. Post-treatment chlorination used to occur within a tank inside the trailer also. Now, pre-chlorination happens in the settling basin, (Figure 19) prior to rapid sand filtration, as the chlorination system broke and was never repaired.

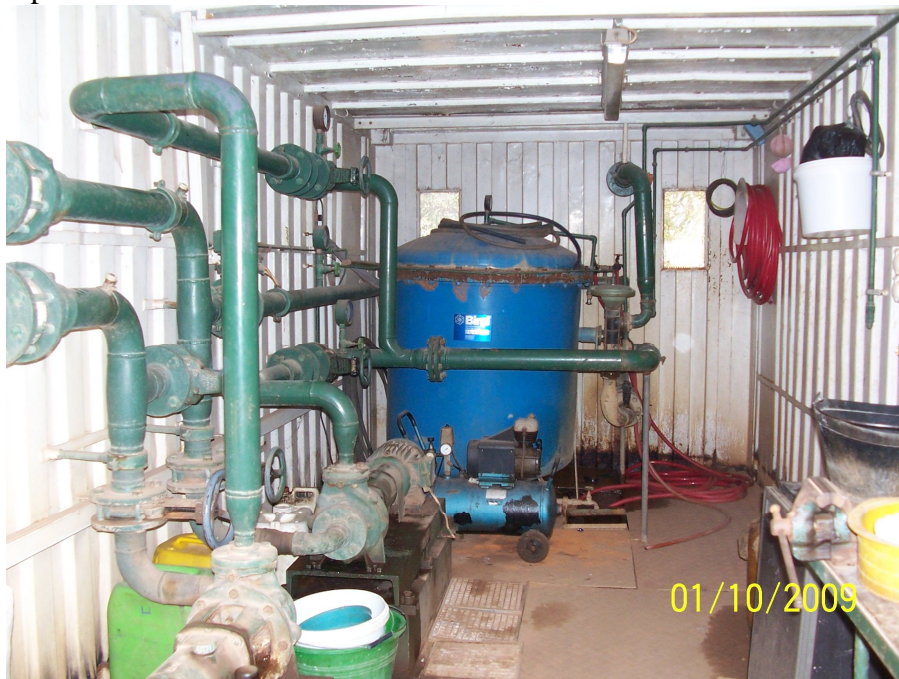
Figure 20: Rapid sand filter

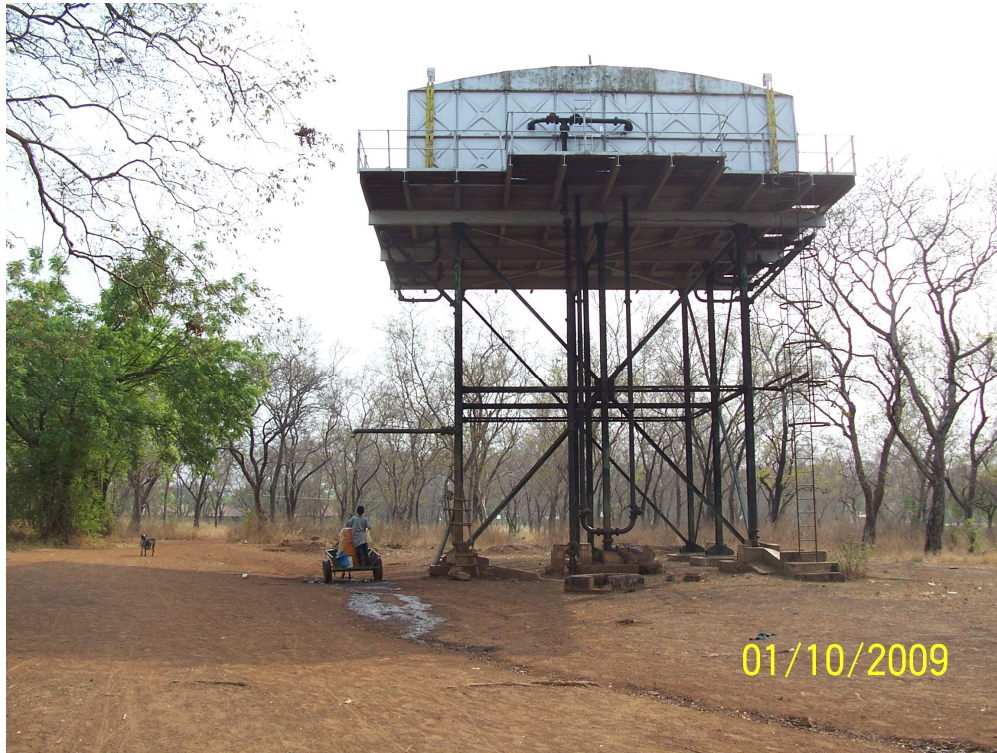
Figure 21: Storage Tank used for distribution to Veterinary College

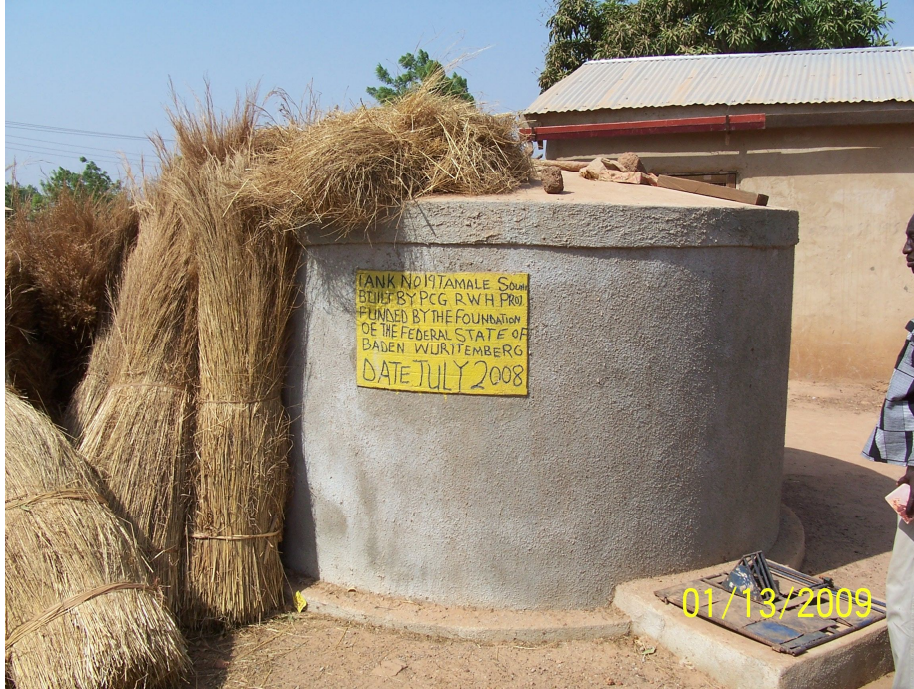
Name: Kakpaille,
Ghana
Number of Users: 7-25
Tank Type:
Ferrocement tank,
Presbyterian Tank
Program
Guttered Roof Area:
18-72m²
Cost: \$708
Systems Surveyed in
Community: 10 of 26
Maintenance Issues:
Gutter failure, leaky
taps, unsupported
downpipes
Water Quality Results:
9-99 total coliform
CFU/100ml, 9 *E.coli*
CFU/100ml

Figure 23: Ferrocement Tank in Kakpaille, Ghana

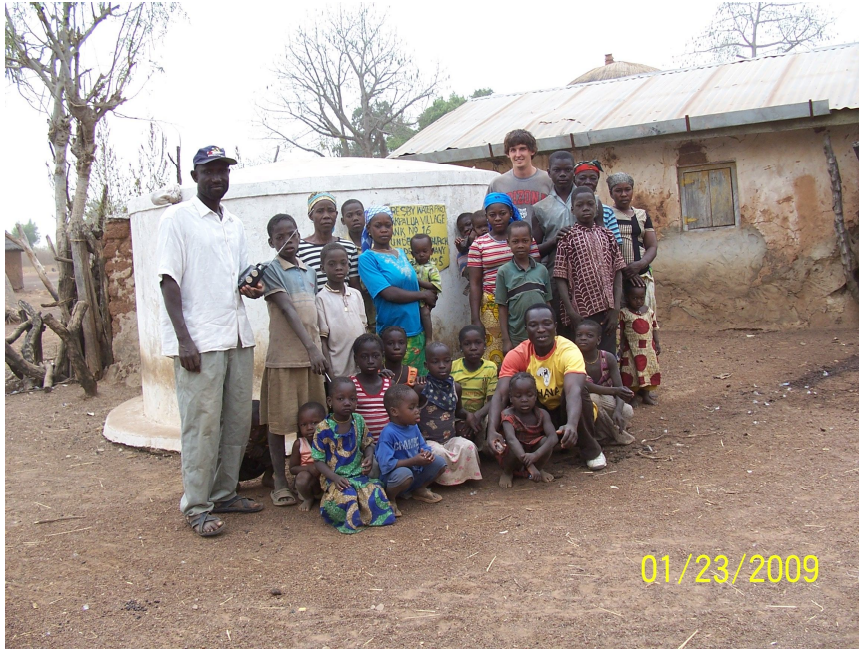
Name: Vogyili, Ghana and Sakpalua, Ghana
Number of Users: 7-25
Tank Type: Ferrocement tank, Presbyterian Tank Program
Guttered Roof Area: 18-72m²
Cost: \$708
Systems Surveyed in Community: 5 of 19
Maintenance Issues: Gutter failure, leaky taps, unsupported downpipes
Water Quality Results: 9-99 total coliform CFU/100ml, 9 *E.coli* CFU/100ml

Figure 24: Ferrocement Tank at Sakpalua

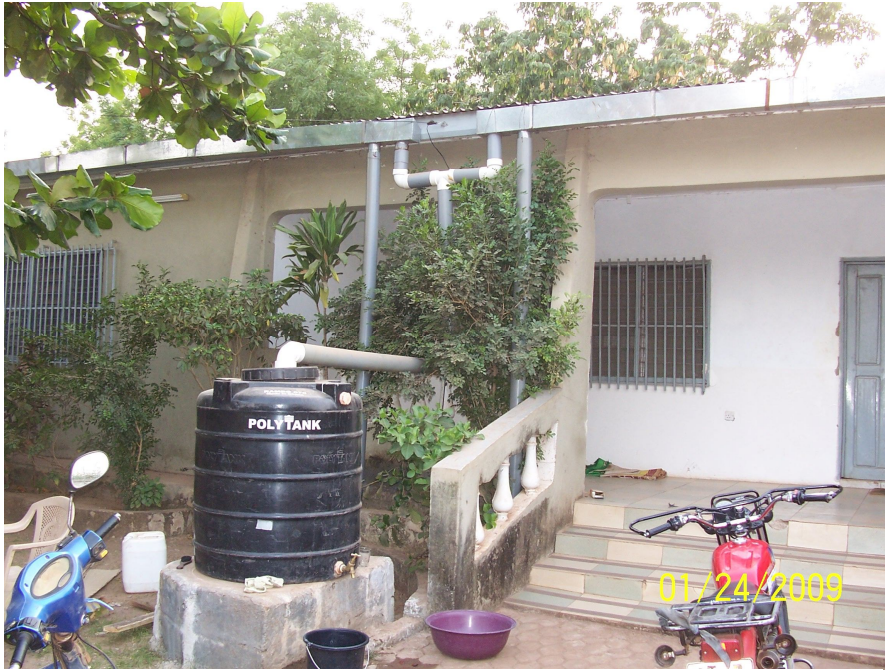
Figure 25: PHW RWH System in Front of House

Name: Pure Home Water House, Tamale, Ghana
Number of Users: 2-10
Tank Type: 2 Plastic Polytank brand water tanks, 1m³ (front of house), 3m³ (rear of house)
Guttered Roof Area: 98 m² (front of house) 106m² (rear of house)
Cost: \$1069
Maintenance Issues: Gutter failure at elbow due to sun rot, failed concrete foundation for rear tank
Water Quality Results: Sample from first flush tank, 9 total coliform CFU/100ml, 9 *E.coli* CFU/100ml

Pure Home Water built a RWH system in the summer of 2008. The system was designed by a graduate student from the Rhode Island School of Design (RISD), Ming Wong, and constructed by Pure Home Water employees and students from MIT and RISD, as well as hired laborers. The system consists of two Polytanks collecting runoff from both the front (Figure 25) and rear of the rooftop. The larger storage tank is located in the rear of the tank. (Figure 26) Two types of constant volume first flush devices are used. The first, located in the front of the house, uses PVC pipe, while the second, located in the rear of the house, uses a small storage tank to capture the first flush. Piped water supply in the past had been very unreliable and often water was fetched from public standpipes or purchased from water vending trucks during the dry season. This water is stored in the plastic Poly tanks when rainwater supplies run out. A failed PVC gutter elbow was repaired in the rear of the home by the author and a PHW employee, Nurideen Mohammed. The foundation for the rear tank had failed and needed repair. The tap for the rear tank was also leaking around the seal at the tank.

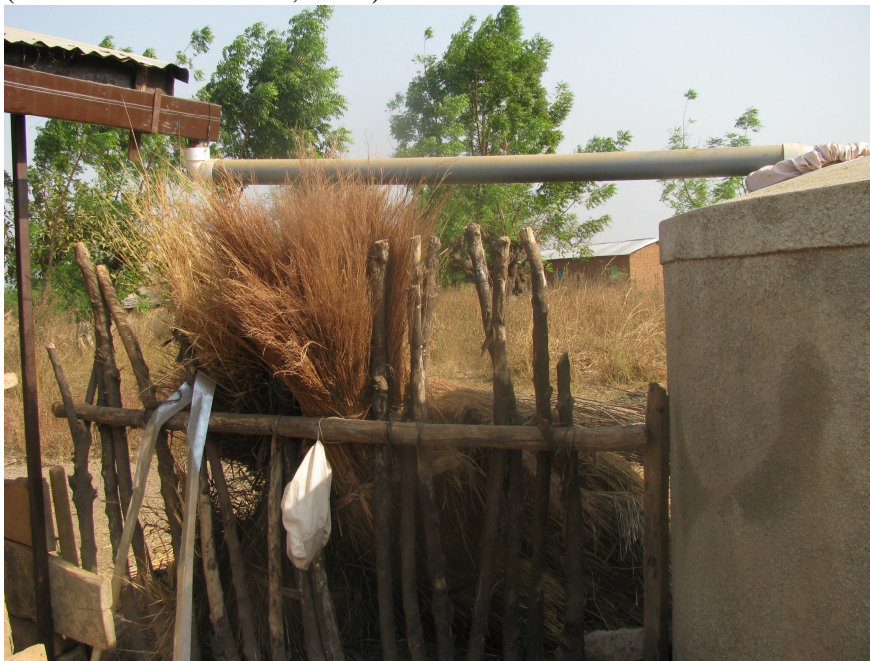
Figure 27: Manual first flush device: Removable Inlet Pipe (Photo Courtesy of Shanti Kleiman)

The three most common types of diversion devices are manual, fixed volume, or fixed mass. Manual devices, like a movable inlet pipe, were the most common system observed in Northern Ghana. While these devices are the most simple, they require the presence of an operator at the beginning of the rain event and for some duration into the storm to operate them. Education as to the proper operation of these systems is important. While they may be mechanically the most simple, they require instruction as to how much water should be diverted from the tank. The amount of time to divert water from storage is dependent on rainfall intensity which varies between rain events. Other factors that affect the first flush include roof material, roof size, slope, exposure, and meteorological factors including rainfall intensity and antecedent dry time (Meera and Ahammed, 2006).

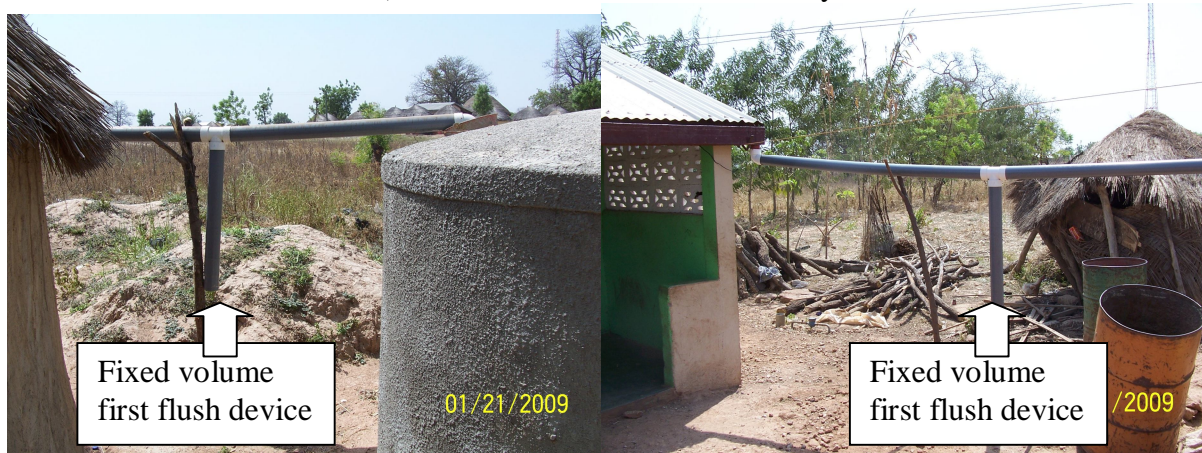
Figure 29: Fixed volume first flush devices: Presbyterian Tank Program

Fixed volume devices divert a fixed volume of water from storage. (Figure 29) These have the benefit of not requiring the tank owner or operator to be present during the rain event. They can be emptied after each event or can be left full, depending on whether or not another first flush is desired at the beginning of the next rain. The Presbyterian Tank Program began to implement fixed volume first flush devices in July 2008. The devices also could serve as structural supports for the inlet pipes, which exhibit significant sag in some locations. (Figure 32) The volume sizing of these devices needs to take into consideration the factors listed above (i.e. roof area, climatic factors, roof material) to act as an effective first flush system.

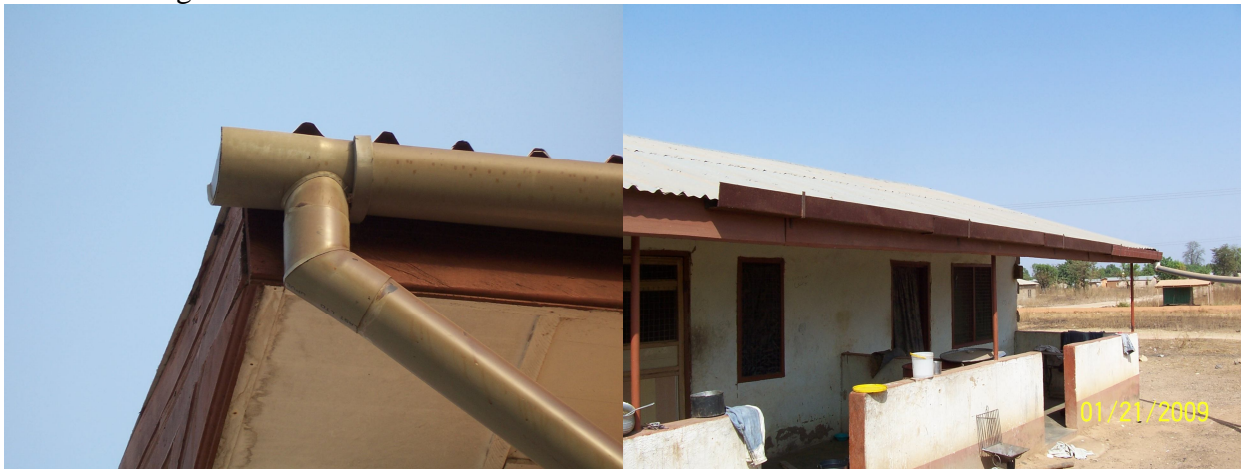
Figure 30: Custom-built gutter system fabricated in Accra using PVC pipe cut in half for gutter (left) and bent steel gutter fabricated by Fuseni gutter (right)

Gutters can be constructed out of many different types of materials. Gutters in the author's survey in Northern Ghana were constructed of three types of materials: halved PVC piping, galvanized steel sheets bent into gutters, and bent roof sheeting. (Figure 30) Gutters were mounted using steel or fabricated PVC brackets.

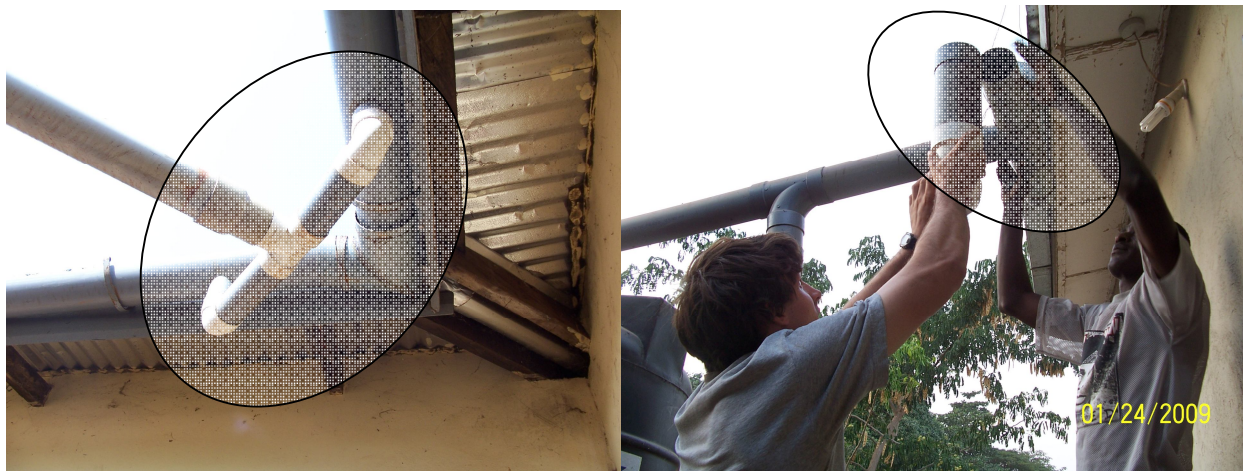
which were performed in January during the dry season, many guttering systems were in disrepair or reportedly leaked. Common failures witnessed in the field were leaky joints or connections between guttering sections and complete failure/detachment from eaves or fascia boards. The guttering system for the third of the Veterinary College's RWH system's had failed near the storage tank and had not been repaired in two years. Durability or ease of repair/replacement should be a key design criterion for any guttering system.

Design issues were also apparent. Sloping of guttering was often inadequate. At Savelugu Hospital, downpipes were not placed at the lowest point in the guttering system, and a corner joint leaked and overflowed during rain events. (Figure 31) The contractor was reportedly returning to fix the issue.

Figure 31: Leakage due to poor design (left) and author replacing sun-rotted PVC elbow joint at PHW house (right)

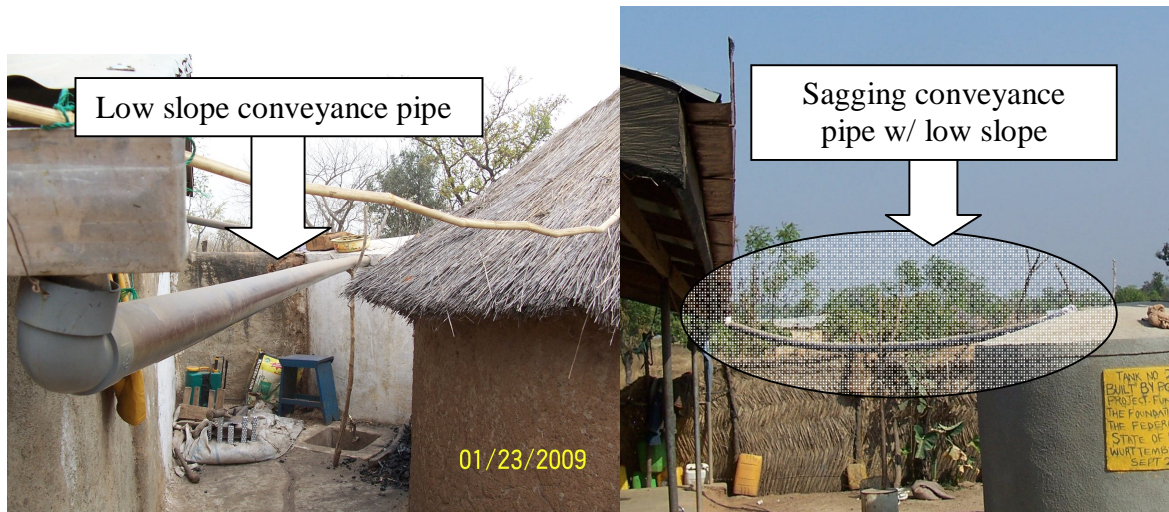
Figure 32: Low slope (left) of conveyance pipe to storage tank and sagging conveyance pipe with low slope (right)

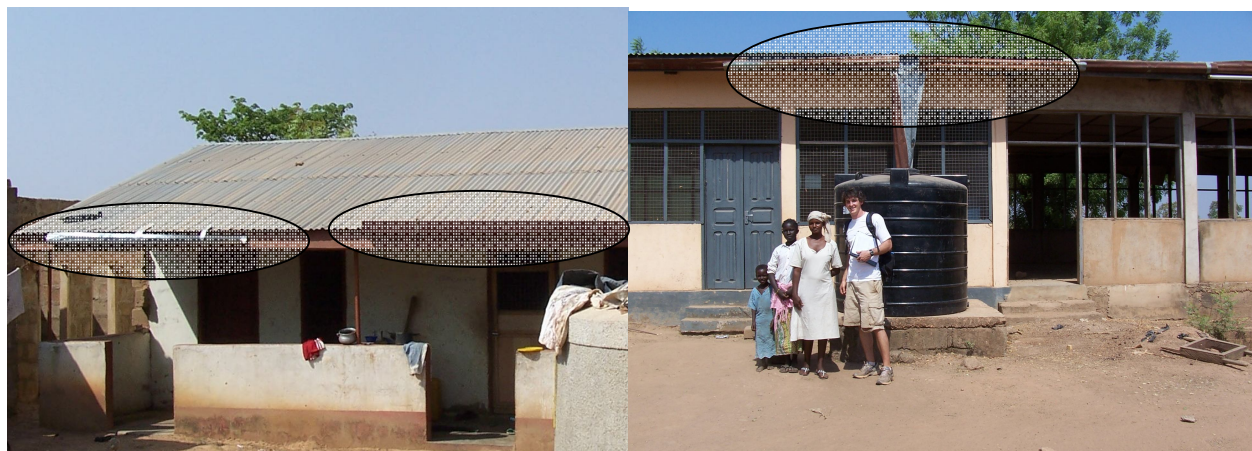
Another design issue that was common was failure to gutter the entire roof area. For the Presbyterian Tank Program, this design decision was based on cost, and the notion that guttering was not the limiting design factor, as tanks would fill by the end of the wet season anyway. From conversations with a technician, each tank was allotted five or six sections of steel guttering. From a cost standpoint, guttering makes up a relatively small portion of the total cost and could represent a cheap way to increase reliability of these systems.

Figure 33: Lack of complete formal guttering, homemade section to far left (left) fabricated guttering using roof sheet (right)

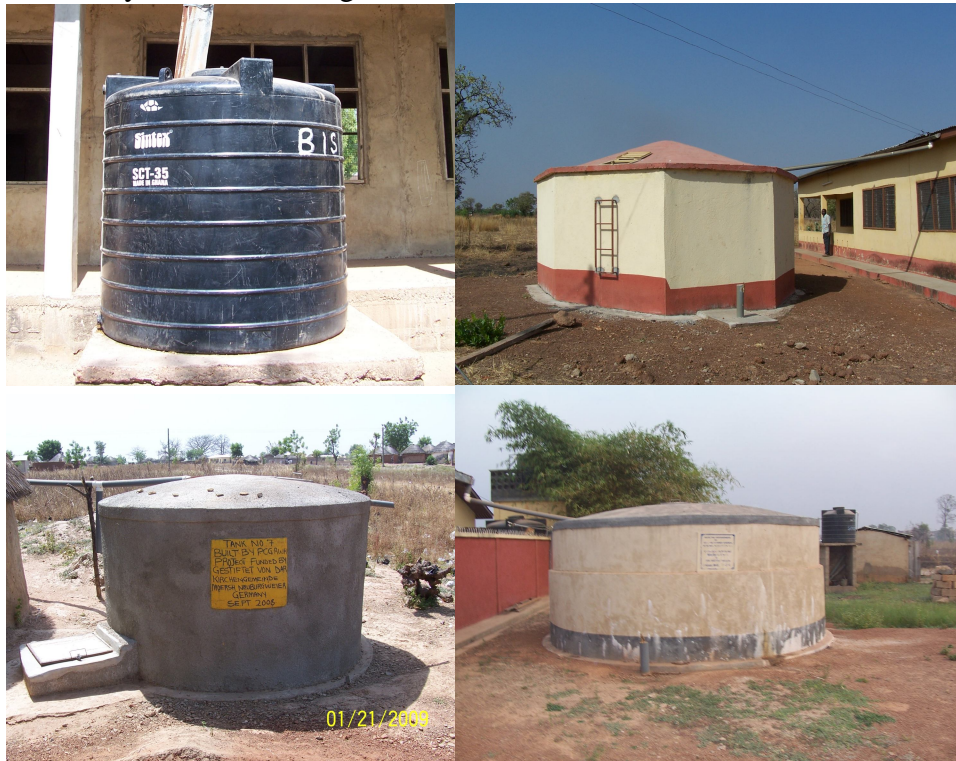
Figure 36: Four Different Storage Tanks: Plastic Storage Tank: Sintex Brand 1m³ (upper left) Cement Block 75m³ (upper right), Ferrocement 10m³ (lower left), Cement Block 30m³ (lower right)

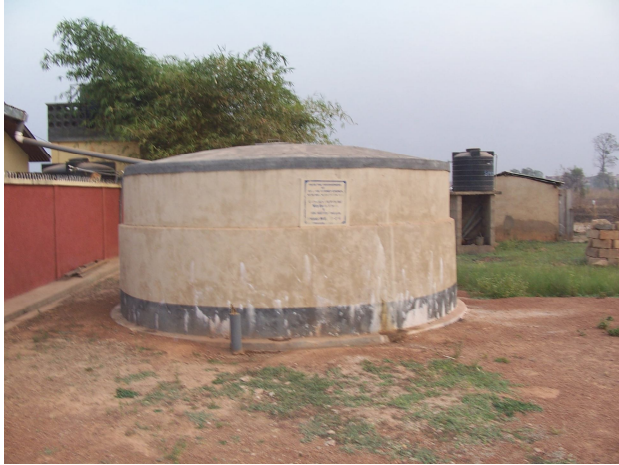
Figure 37: Leaky storage tank

The durability of storage tanks is critical for the success of any rainwater harvesting project. A leak could mean the loss of a storage volume of water and costly repairs. Peter Tisakia, a contractor building 30 m³ cement block tanks, explained that occasionally the tanks would not set properly and would leak at joints in the blocks. Repairs to cement block tanks involved the purchase of waterproof coating from Accra and expensive repairs which he would have to return to complete after the completion of a project, if leaks occurred. (Figure 37)

While leaks in below-ground storage tanks are difficult to find and repair, leaks in above ground ferrocement tanks are relatively easy to find and easy to repair. The leaking area is chiseled out, wetted, and cement applied to the area. It is then covered and cured for three weeks. Some repairs can even be made while the tank is holding water. (Gould and Nissen 1999) Plastic and steel tanks are very difficult to repair if leaking occurs. One ferrocement tank seemed to seep water during the nighttime. This could either be due to expansion/contraction problems or lower evaporation during the nighttime making the leak visible. Leaky taps were another issue witnessed in Ghana. The tap on the tank in the rear of the Pure Home Water House leaked around the seal. A few taps in the Presbyterian Tank Program that were surveyed could not be fully closed and dripped constantly.

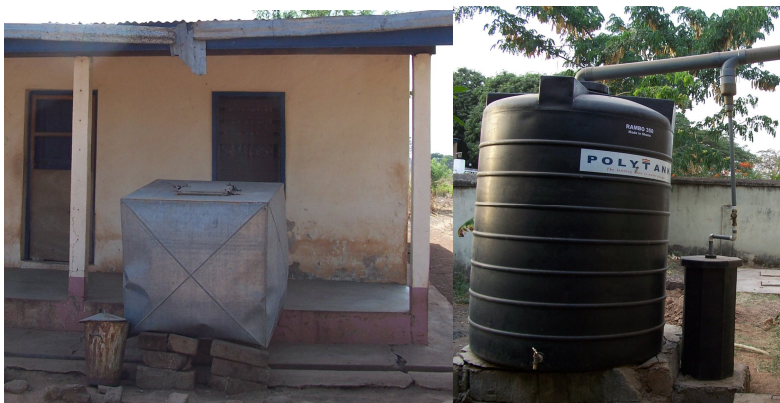
Properly siting and providing solid foundations for water tanks is also important. Even plastic water tanks require a proper foundation. The foundation was not properly set and cracked after only a year at the Pure Home Water House. At the Ghana Health Clinic, the 500 gallon galvanized steel tank was set on bricks placed at the four corners and allowed to sag in the middle, producing leaks and cracking. (Figure 38)

Figure 38: Foundation issues: Brick support at corners of storage tank causing structural damage and leaks, Pong-Tamale Health Clinic (left), cracked and broken foundation, PHW house (right)

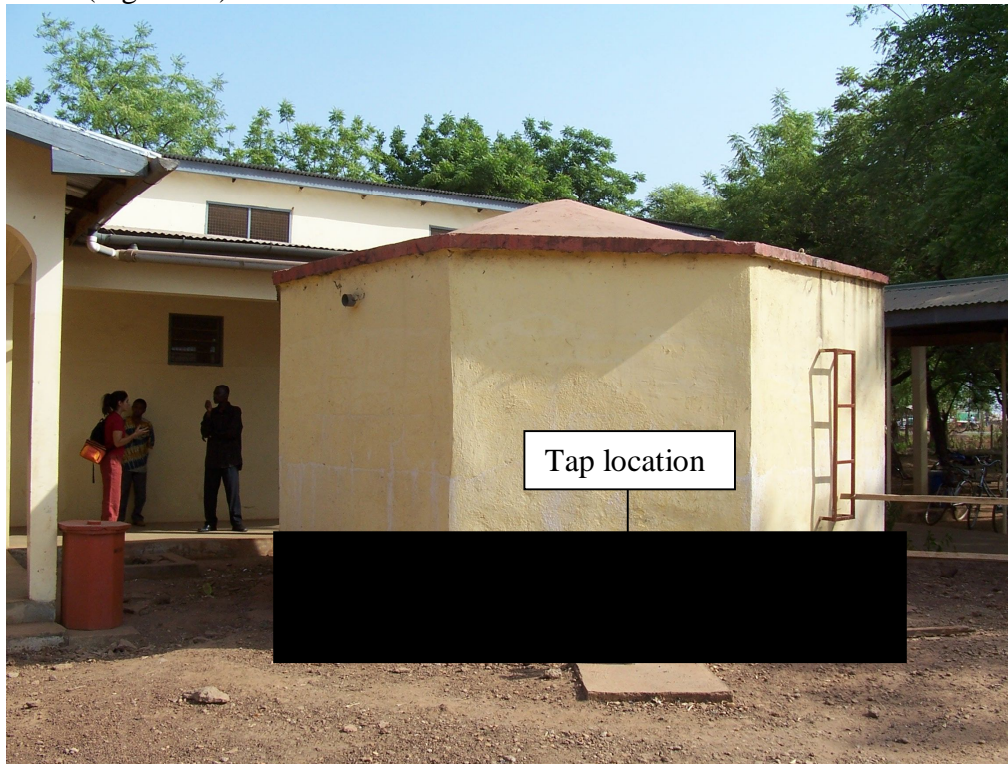
World Vision also constructed another octagonal storage tank at Savelugu Hospital in 2008. (Figure 16) The tank failed to fill with water during the rainy season due to a problem with the guttering. Water was not diverted to storage at the lowest point in the guttering system so backup and spillage occurred. Also, in this design, as discussed in the Chapter 7, a large portion is considered “dead storage,” water that cannot be accessed via the tap or drained from the tank. This renders this portion of the tank unusable and prevents proper cleaning. The dead storage space can be seen in Figure 16 as approximately the area painted red.

Figure 39: Dead storage in Savelugu Hospital Tank (funding organization: World Vision) (Painted Red)

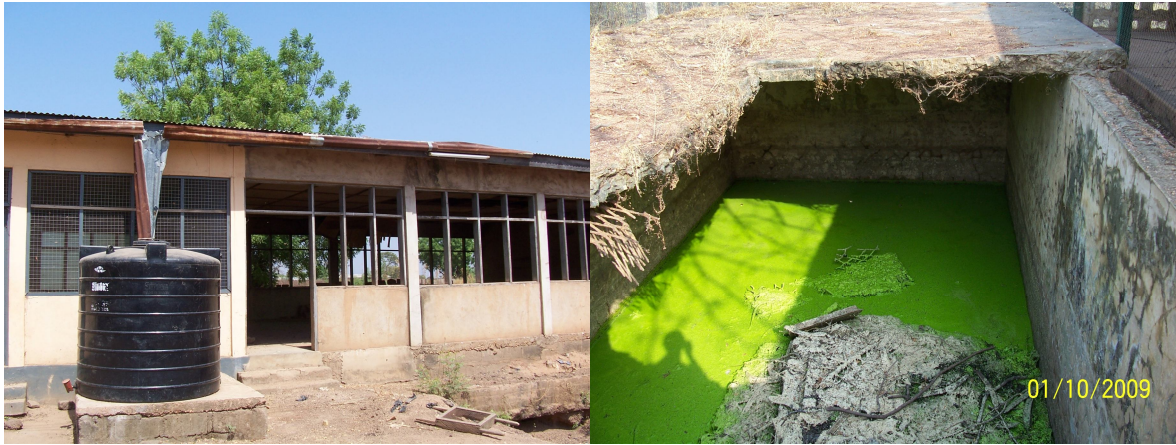
Figure 40: Durability: Unknown lifetime of plastic storage tank in full sunlight (left), structural failure of roof of subterranean reinforced concrete tanks, Veterinary college (right)

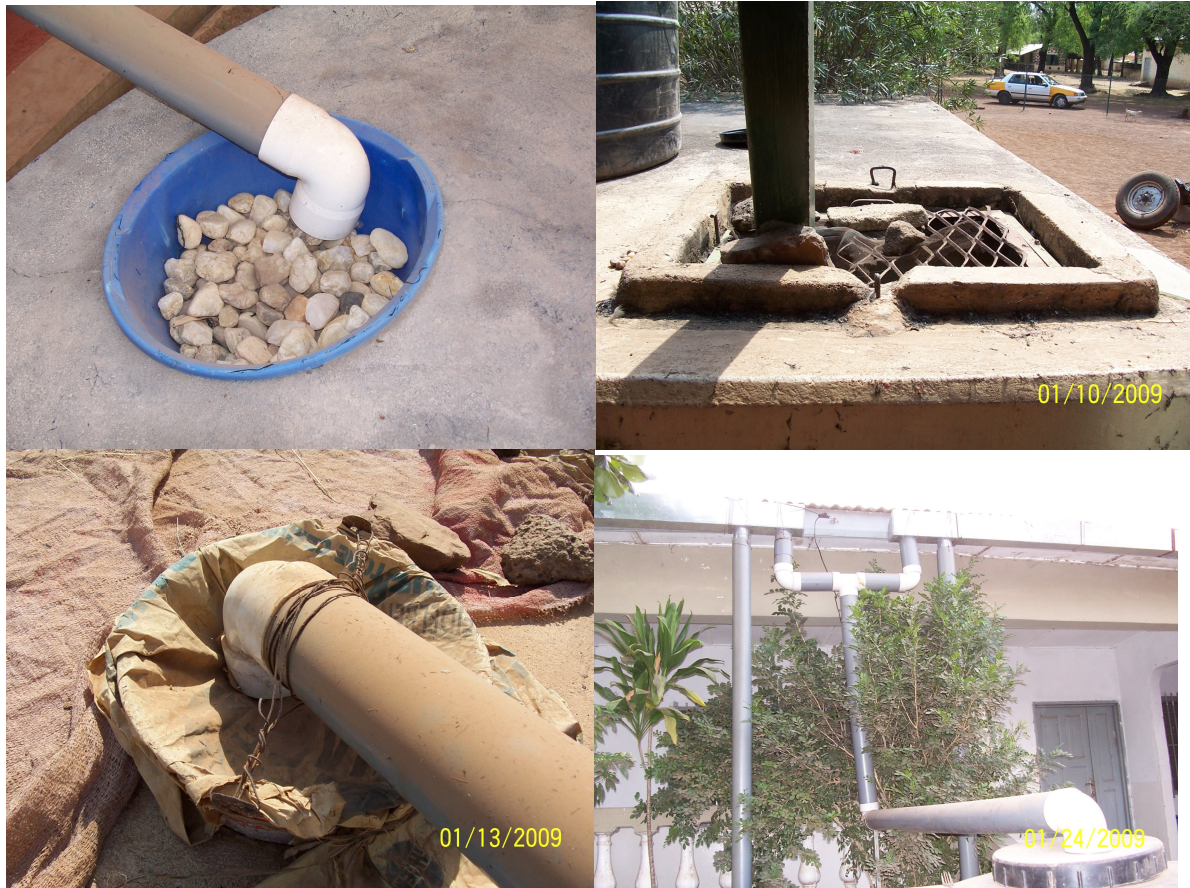
However, the fine wire mesh was in poor repair and did not cover the entirety of the opening. (Figure 41)

Figure 41: Examples of Storage Tank Inlets with Pre-filtering: Rough gravel in bucket pre-filter(upper left), degraded wire mesh partially covering inlet (upper right), cloth filter over gravel pre-filter(lower left), sealed tank entry after first flush with leaf screen (not visible) in guttering (lower right)
