Assessment of Rainwater Harvesting In Northern Ghana

Master of Engineering in Civil and Environmental Engineering
at the
MASSACHUSETTS INSTITUTE OF TECHNOLOGY

June 2009

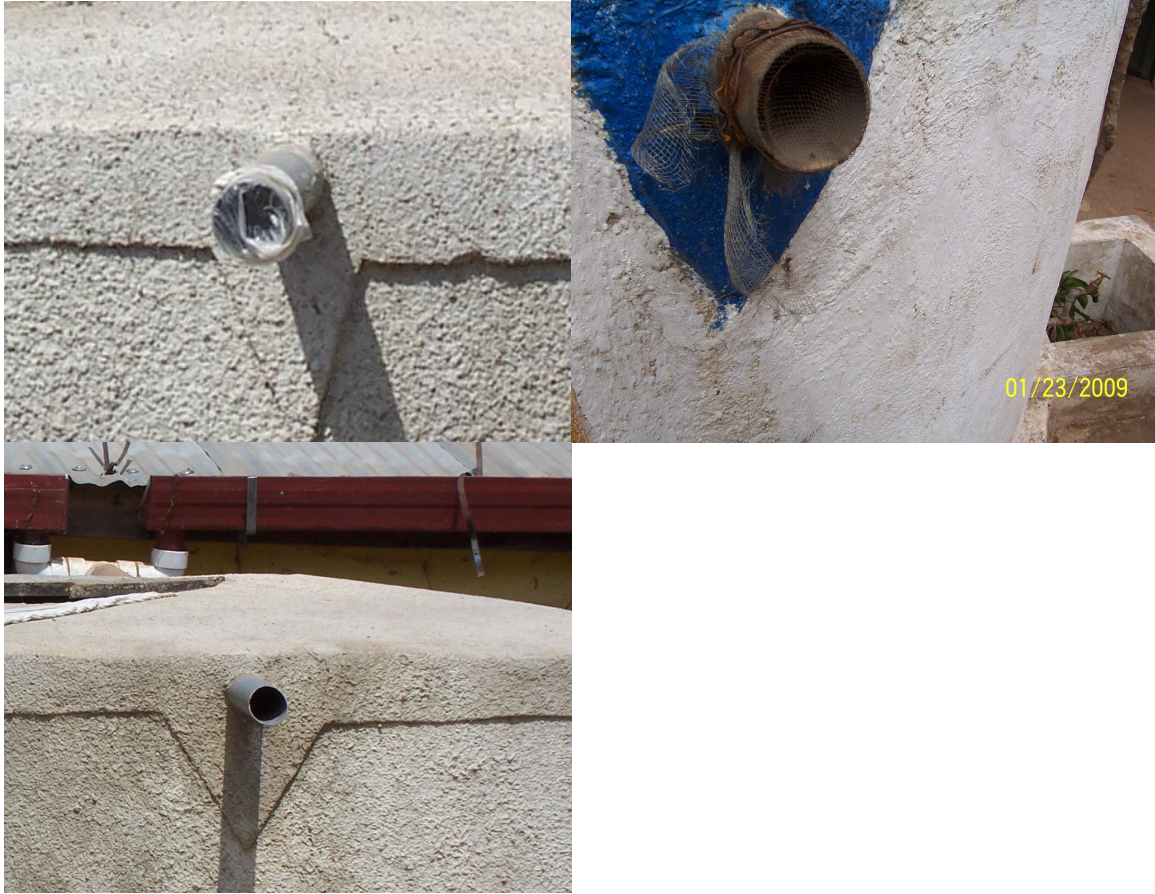
Figure 42: Overflow Pipes at Presbyterian Tank Program tanks: Covered (upper left), Screened (upper right) and Unscreened (lower left)

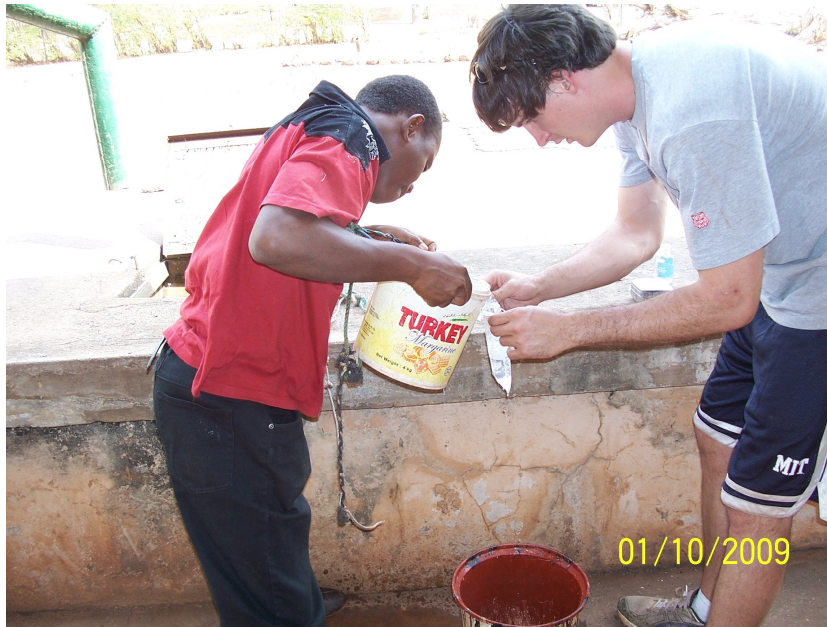
Water samples were taken from water cisterns at 24 visited sites. The source of water and method for fetching varied among samples. In the event that a sample could not be collected from the tap, the local method for accessing the water source was used, typically involving the use of fetching buckets or cups. Secondary contamination was possible in these tests from the fetching bucket or cup. (Figure 53) Whirl-Pak® 100 mL sampling bags were used to collect water from taps or where necessary, using local fetching practices (cup, bucket.) The method of sampling was noted at each location. Water samples were transported to the laboratory on ice in coolers. The samples were refrigerated until tests could be completed. These samples were processed within twenty-four hours of time of sampling. Two tests were completed to determine the microbiological quality of the samples, Colilert 10mL predispensed presence absence test and 3M Petrifilm.

Figure 53: Collection of Rainwater Sample from Underground Cistern at Veterinary College Using Local Fetching Bucket (Used Food Container,) Pong-Tamale, Ghana.
